Section 1 Sept 2005

First 8 foot section of the rehab is at south end of the greenhouse. Initial focus is on the outer enclosure. The glass removal and replacement is done starting with removal of the vent sashes and removal of glass in vertical sequence, 3 columns at a time. In this way, glass, wood and steel repairs can be completed with access to the vertical column from the adjacent opening.

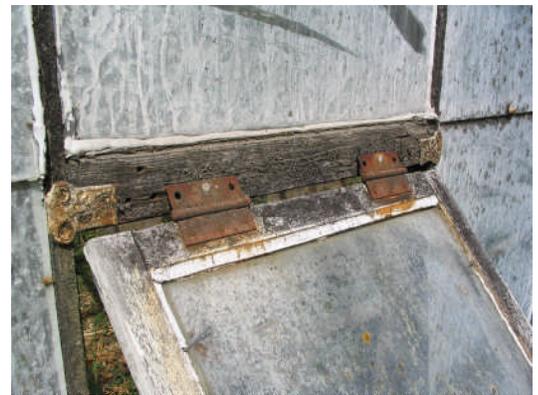
Wood muntins, mullions and sash in the building shell have a white painted finish on the inside and exterior surfaces. This finish tests positive for lead content.

The existing paint is assumed to be the original finish. The wood is typically exposed with partial paint coverage remaining. Sash frames are made of fir, indicating they are not original.

All wood components are painted to protect and preserve the wood. Two coats of exterior grade alkyd primer are brush applied to existing and new wood. Surfaces are finished with two coats of acrylic solid colour stain following re-installation. Lower sash frames will be re-used if sound. All replacement sash will be made of yellow cedar. New sash are manufactured as required off site. The existing sash is used as a model for new fabrication, as there are no design drawings or samples of original fabric. Steel and cast iron are primed with marine red oxide and finished with marine enamel.

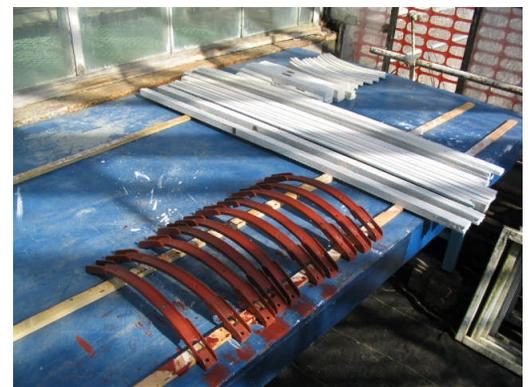
First coat of primer applied with Penetrol 10% to enhance the penetration and adhesion to the scraped and sanded wood and epoxy filler. Second coat of primer is applied after sanding, without thinning, after installation. Application to all surfaces provides uniform coverage and appearance, and creates a good surface to accept glazing putty. Paint over glazing putty requires additional curing time, due to the oil content of the putty. Stain application over putty does not result in an acceptable finish.

Acrylic solid colour stain will continue to be used on interior surfaces due to the benefit of application in humid conditions, long service life and ease of maintenance. Putty will be finished after substantial curing time to allow initial drying of surface oils. The finish for putty and adjacent wood surfaces shall be an exterior grade alkyd oil base paint. System Three Rot Fix and Sculpwood epoxy putty makes viable the retention of 80% the original wood .

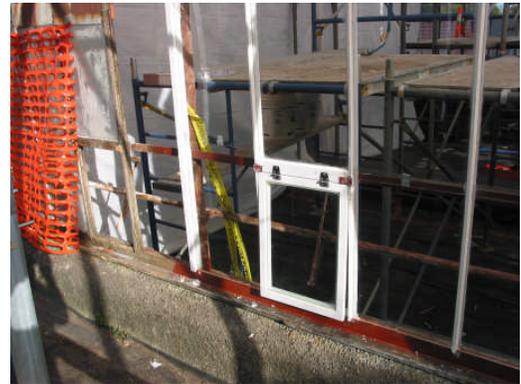
The existing wood components are substantially sound and will be re-used with the aid of epoxy resin stabilizers and fillers. Future rot will be inhibited by insertion of borax at high moisture exposure locations such as the base of the vertical glazing frames. We are able to use 25 percent of the lower sash.

Preservation of wood components is accomplished with careful removal and preparation using hand methods and remedial repair methods. The integrity of the steel structure is assured by replacement of deteriorated fasteners with high quality contemporary materials. Drawn glass is recovered and re-used to its best advantage to demonstrate the original character of the light.
