## Section 10 Jan 25, 2006

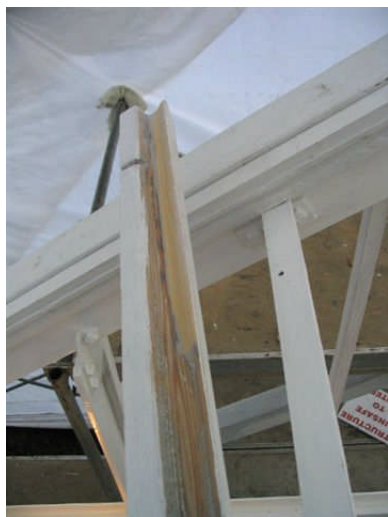
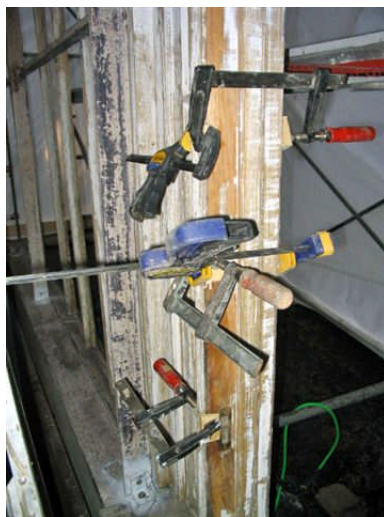
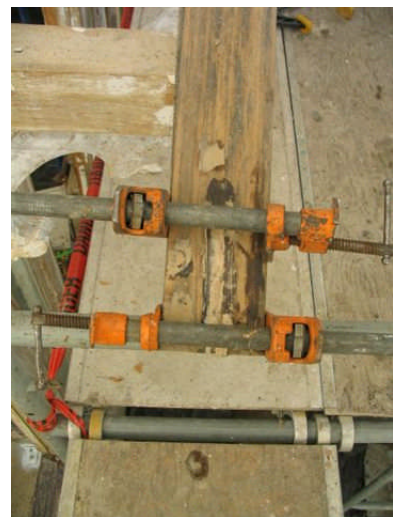
Significant corrosion of angle iron purlins requires some replacement with new material. Deterioration of wood requires extensive repair in both section 9 and 10.

Repairs to wood and steel are made in place where possible.
