Section 3 Date: October 5, 2005

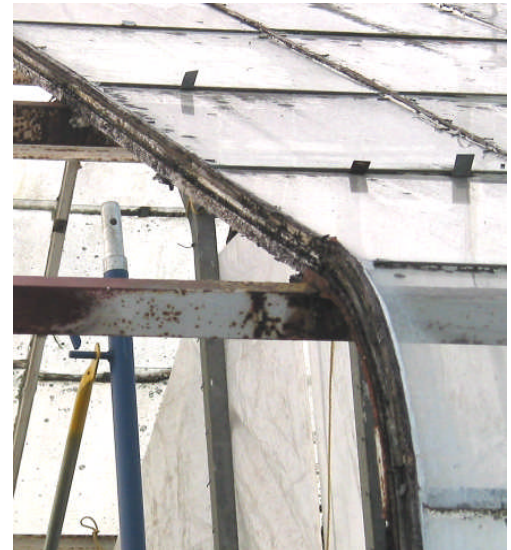
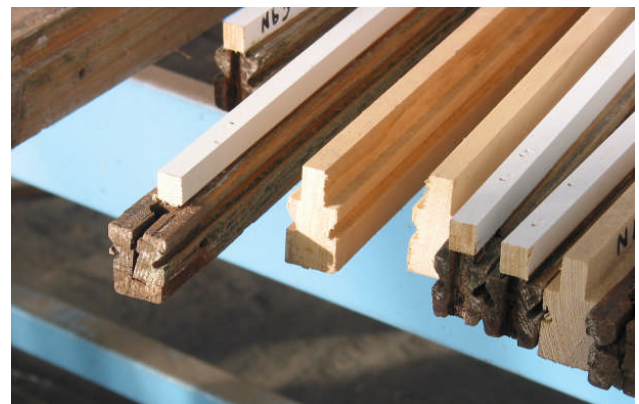
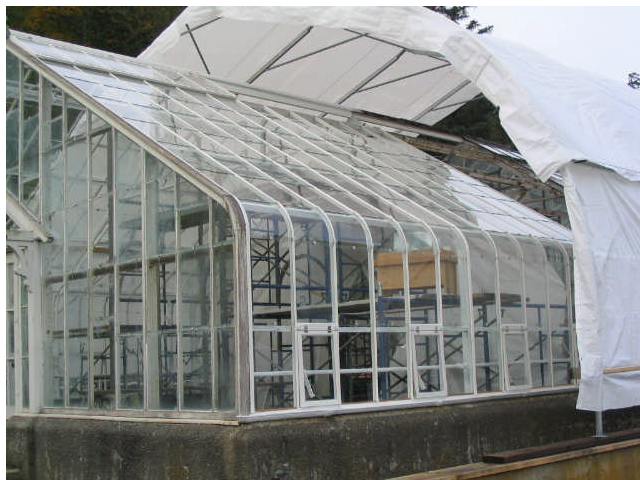
Glazing muntin in the roof and wall are largely sound, but the exterior portion that is exposed between the glass is eroded due to weathering. The pointing and glazing of section 2 was difficult due to the low profile and irregular shape of the weathered muntin.

The shoulders of the glazing muntin are generally uniform and sound due to the cover of glass and caulking. If the weathered nosing is removed, the remaining body of the glazing strip can be built up with new material.

Yellow cedar strips fabricated on site, are applied to the cypress base to build up the profile to original dimensions. The use of Titebond III adhesive with stainless brad nails creates a permanent lamination. The rehabbed muntins provide reinforced strength, full depth of relief for putty application, and a strong, straight line for the very prominent projection of the muntin between rows of glass.

Some of the wood muntins will be modified to allow new material to be laminated onto to original cypress muntin

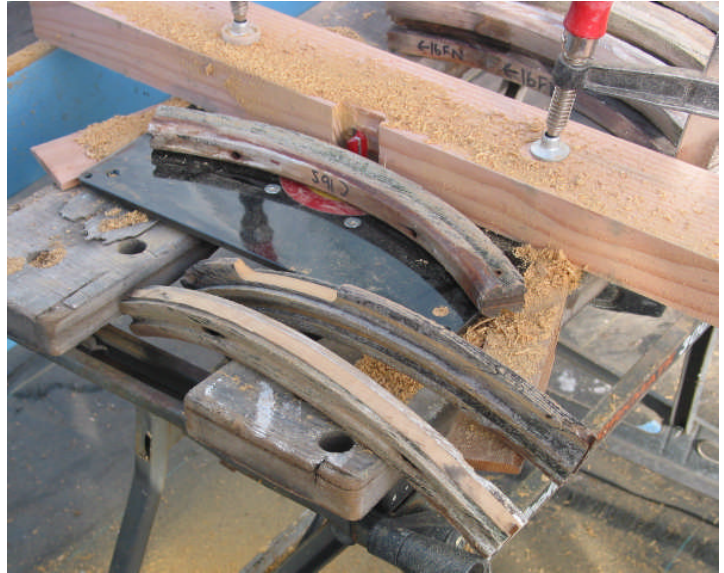
Based on a dramatic improvement in glazing, we will set up to remove and replace muntin nosing through out the balance of the project. Deteriorated condition of about 20% of original material will necessitate complete replacement.

Most of the wood original fabric will be preserved and with uniform glazing, be protected from exposure to rain for years to come.

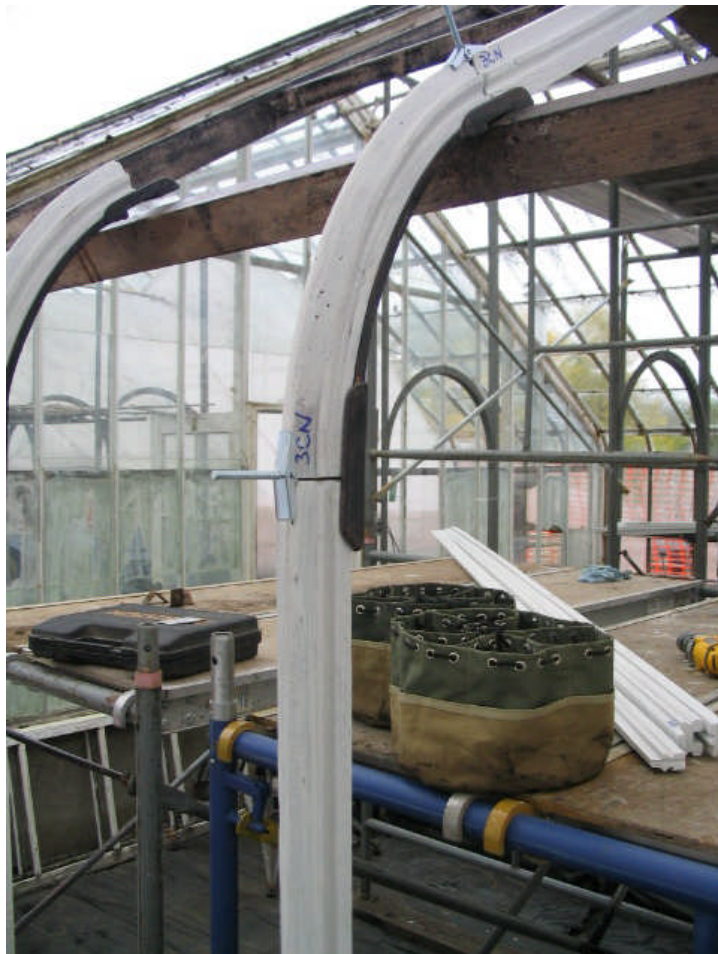
Effort is being made to conserve as much of the wooden fabric as possible. This modification will be applied to the curved eave muntins using steam bent pieces. The over all result is greatly reduced replacement.
