Section 5 November 2, 2005

As we relocate the shelter, some of our new work is exposed and we can observe the performance of the building in the rain.

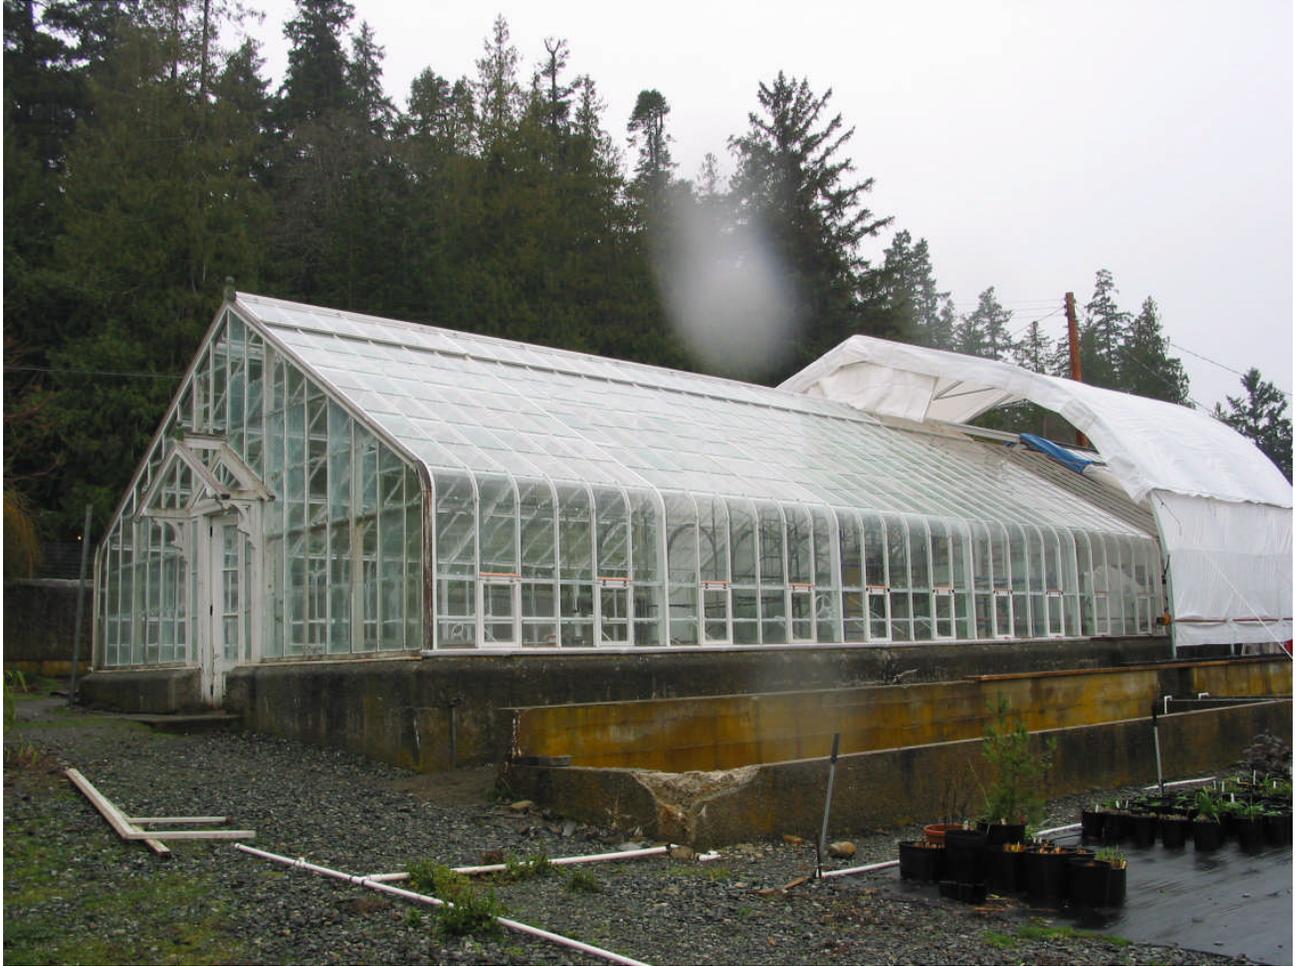
Water running down the glass is traveling directly into the lower sash opening. Other water entry points are marked and we revise some of our practices to eliminate these leaks.

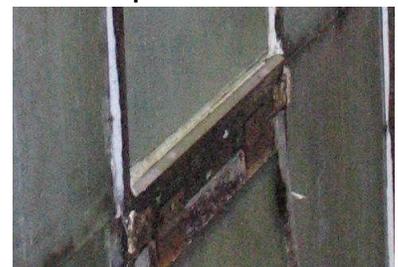
Rain running into the lower sash opening could be redirected to drip off the wall with the addition of a flashing. Existing flashing made of stainless steel are ineffective because of a shallow projection.

Temporary fasteners used at the eaves allow water to leak in at the joints between the wall and the roof.

The gutter at the upper sash leaks at the joints.

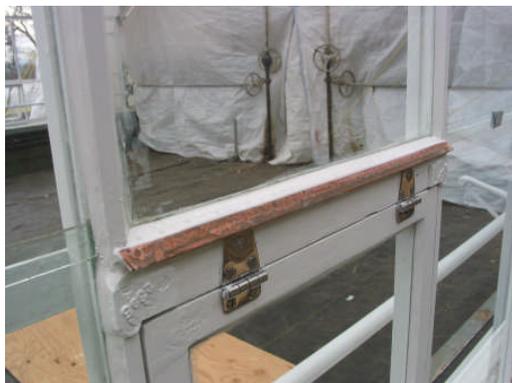
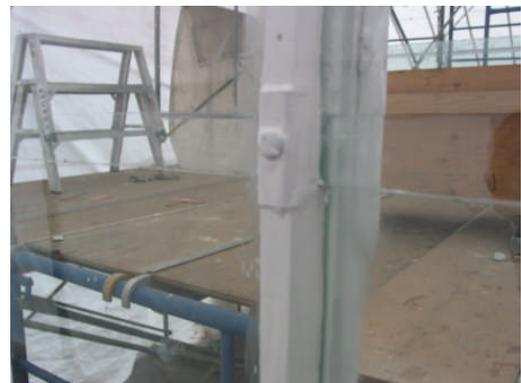
Wall muntins and mullions have a consistent problem with rot at the base near the attachment to the cast iron sill. As part of the repair and stabilization of this area, an impel rod is inserted into the wood, and enclosed with a wood plug. When exposed to moisture, this rod releases borax as an inhibitor to new rot development.

Monitor leaks and tag locations of water entry so that source of entry can be located and repaired.
