Section 8 December 12, 2005

Context

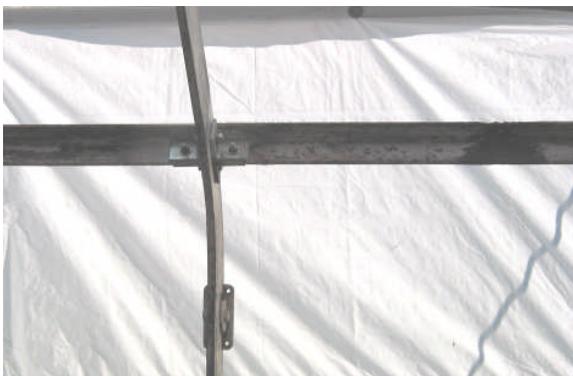
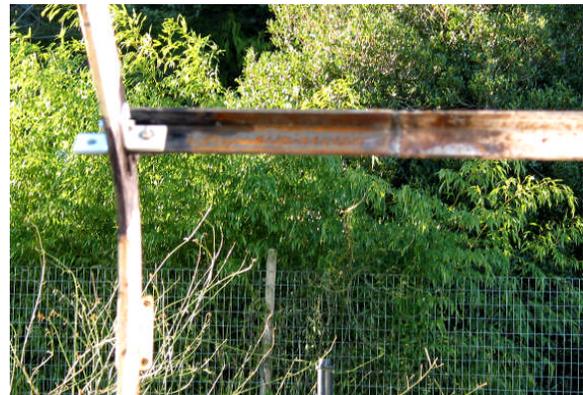
Corrosion is advanced in the angle iron purlins and the fasteners. A typical location for corrosion is above the lower vent sash. In this section, most purlins and clip angles are deteriorated. Perhaps the proximity of the chimney may have resulted in additional acidity deposited on the building from the coal and wood heating.

We have revised our flashing installation to direct run off at the lower vent sash to drain at the centre of the opening away from hinges and assembly joints.

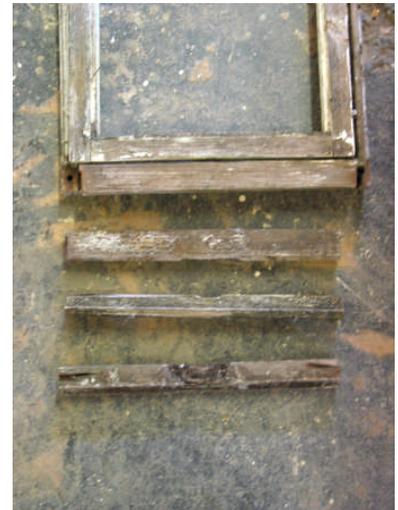
Caulking of joints in the wood roof peak and upper sash gutter is done to reduce rain water entering the building and rusting the structural iron.
