Section 9 January 3, 2006

Context

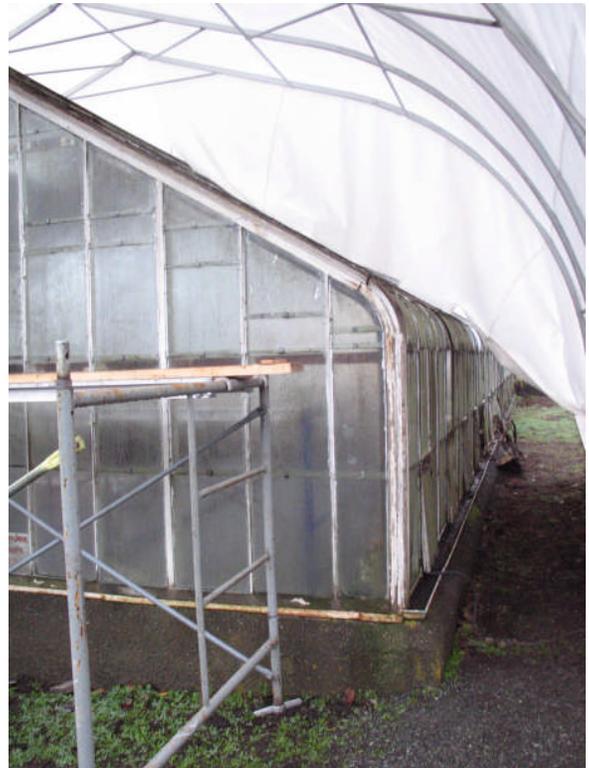
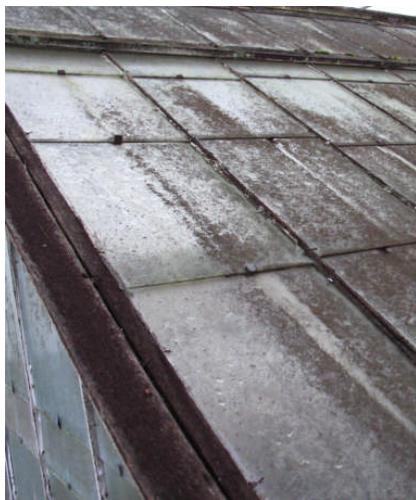
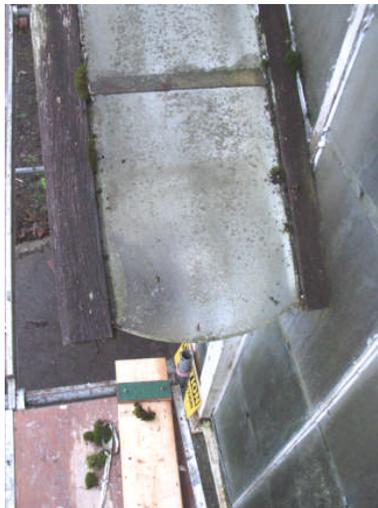
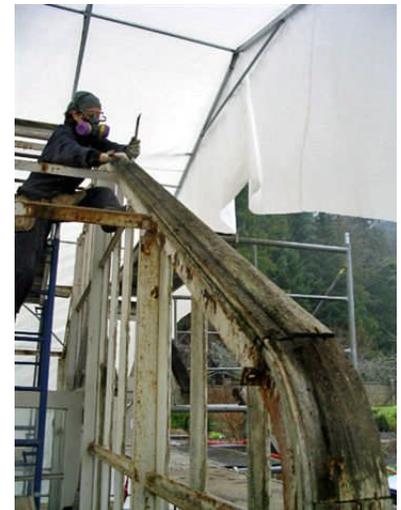
Exposure and disuse has resulted in a heavy buildup of growth on the surface of wood, steel and glass. Material is difficult to handle due to the wet slippery surfaces. The gable wall is fabricated as a sash assembly. Door frame and porch are built as one unit. The wall is miss-aligned due to the disintegration of fasteners.

Wood must be moved to another area to be dried prior to preparation.
Wall assembly will remain in place to be dried, prepped, repaired and painted.
Wall glass will be numbered to allow re-installation based on original placement.

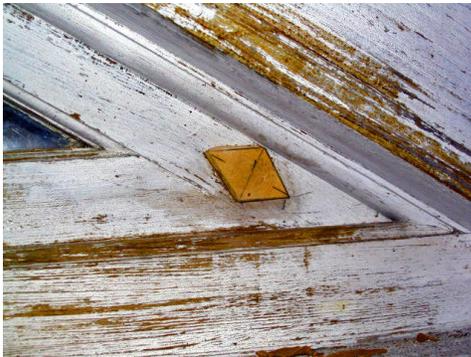
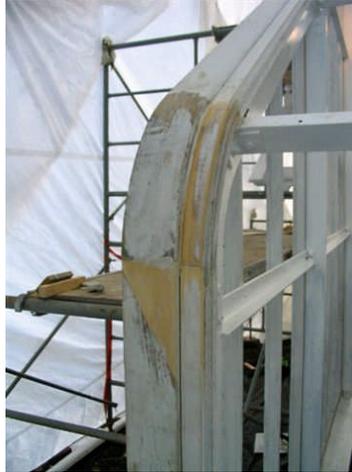
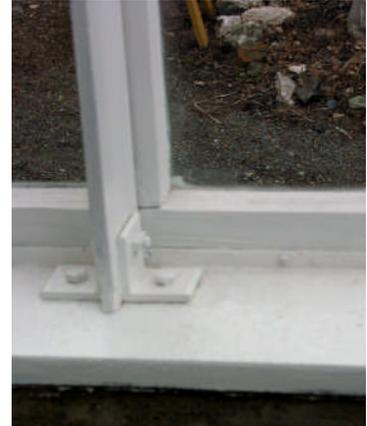
Electrical fixtures and conduit have been removed and holes patched and repaired. Steel repairs include custom made angle brackets that attach wall muntins to the cast iron sill. Some cast iron is replacement with fabricated steel. Original pieces are collected for repair by welding.

Severe storms have threatened safety and damage. Additional time and effort is spent on repairs to the shelters. Glass is lost from the exposed original sections. No damage has occurred to the new areas.
