Section 14 March 13, 2006

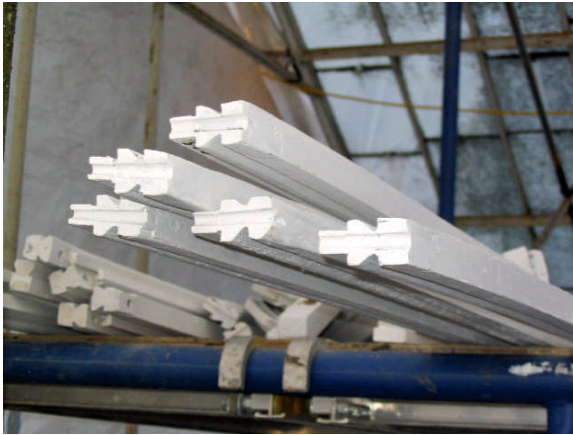
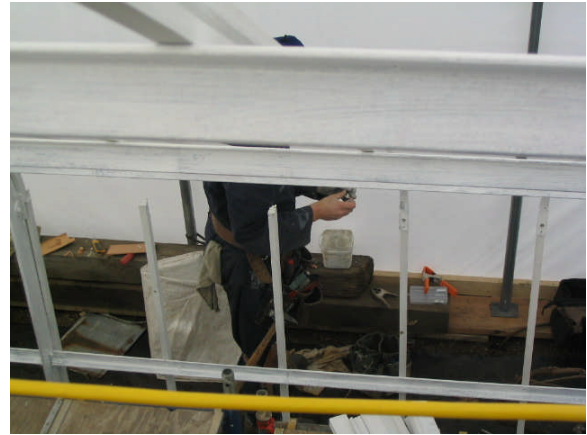
Progress to date is the completion of installation of wood for both sections. Glazing begins and progresses horizontally across both section 13 and 14.

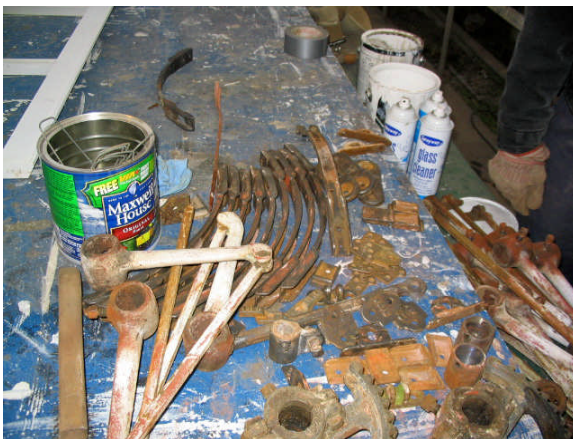
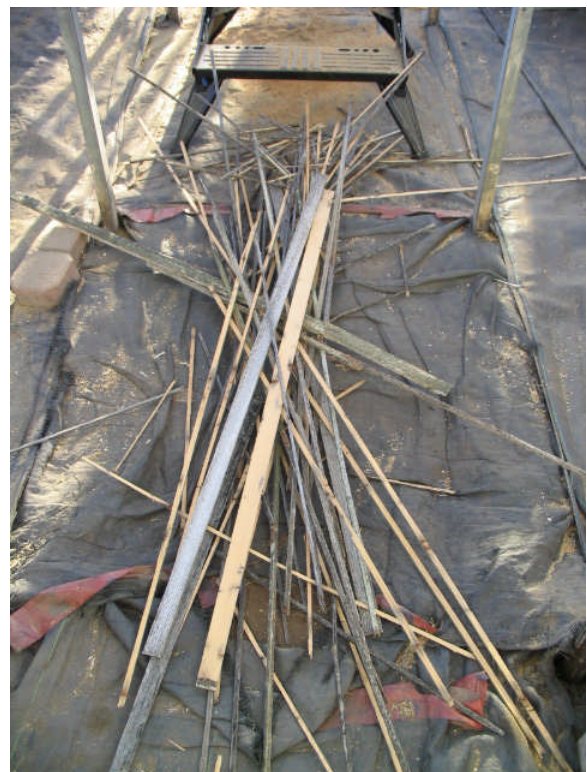
Quantities of glass, metal and wood components being processed at once provide opportunity for efficiency, but cause more storage demands.
