## Section 13 March 2, 2006

With the completion of the north room, we move into the area that has suffered the most deterioration due to long periods of exposure with much of the glass lost. We will plan the work completely for a double section approach to complete 13 and 14 by the end of the month.

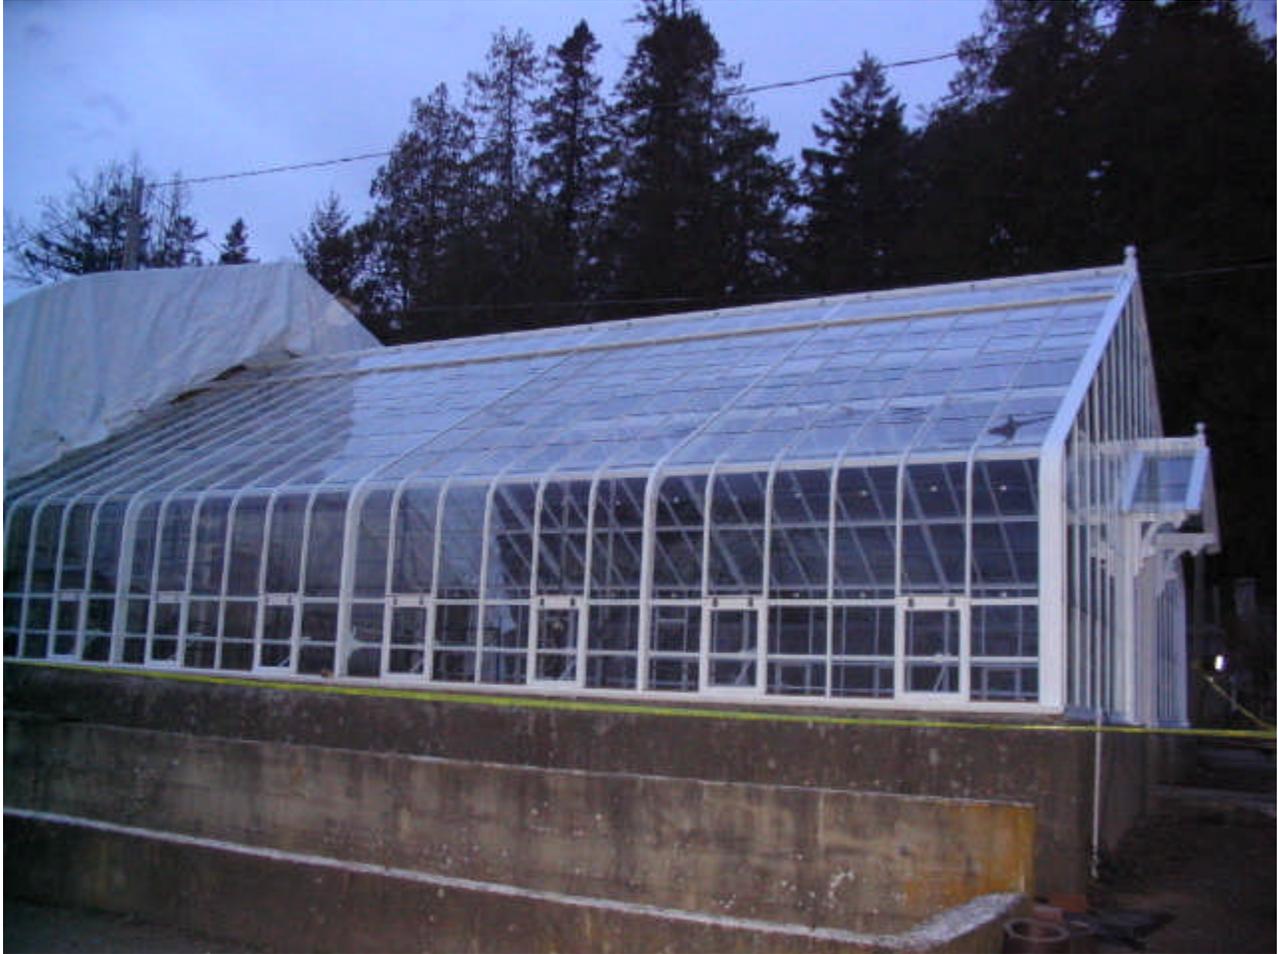
Vent operator shafts are replaced in this area due to corrosion that has reduced the wall thickness of the pipe to less than 50% in areas adjacent to the cast iron arms. An attempt to understand the unusual corrosion results in speculation that there may have been high acidity in this central part of the greenhouse due to the long term presence of fruiting vines or the early exposure to acid precipitated from the wood/coal boilers.

Removal of glass and wood will be completed before the shelter is moved. We prefer to do the metal prep and repairs under wet conditions and do cleanup immediately before painting takes place.

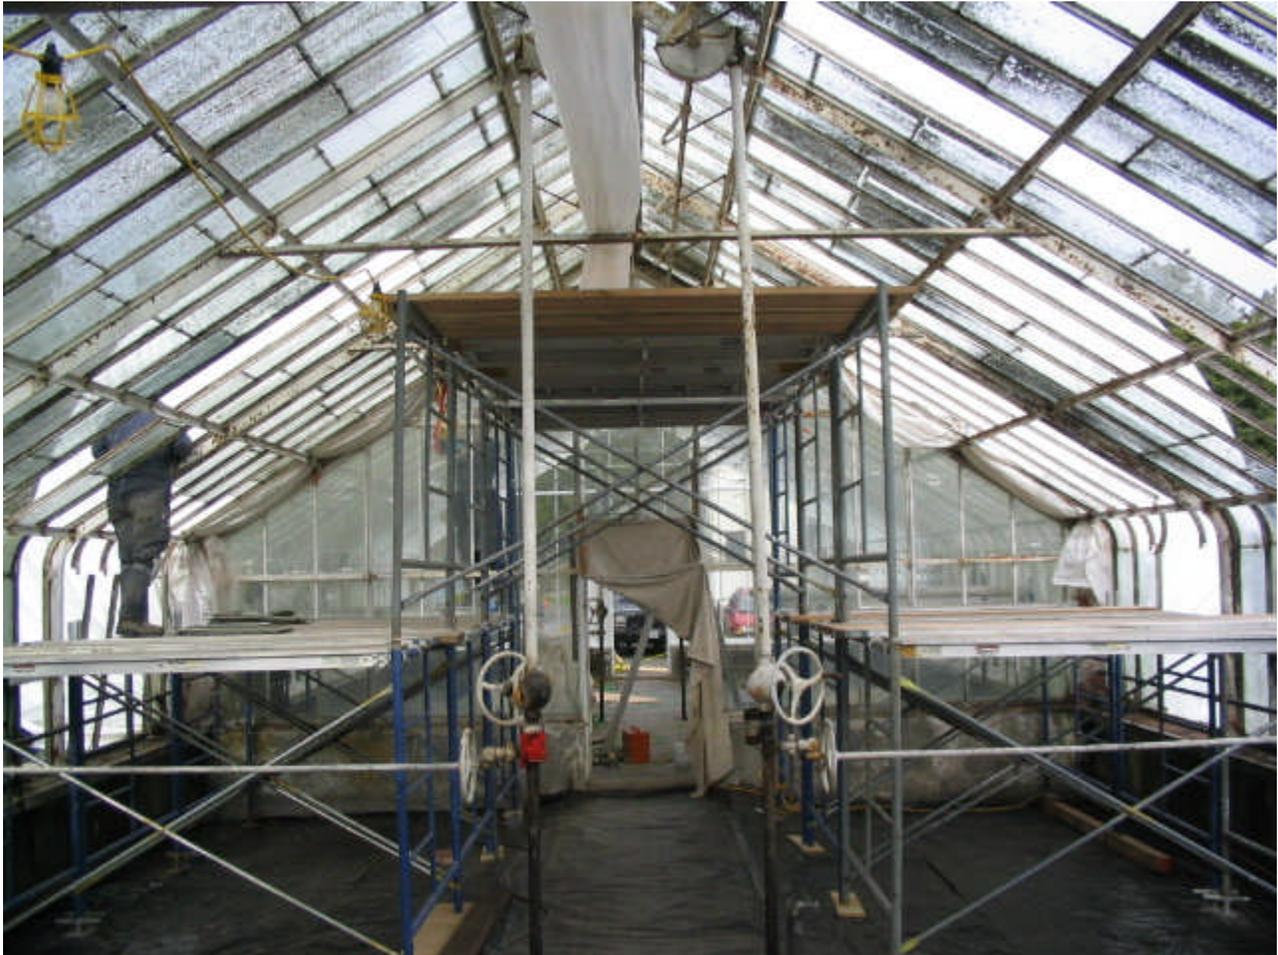
Our completion includes the work of the interior wall. With the glass removed and tagged for replacement location, wood prep is completed in place. Repairs and prime coat are done before the glass is re-installed. Most of the glass is intact. Small repair pieces are added. One piece of original glass is replaced due to curvature that has developed over time.

The wood glazing bars or muntins of the roof and wall require replacement due to their extremely bad condition. Replacement with new yellow cedar muntins increases to 25%. I anticipate similar proportions for the balance of the project.

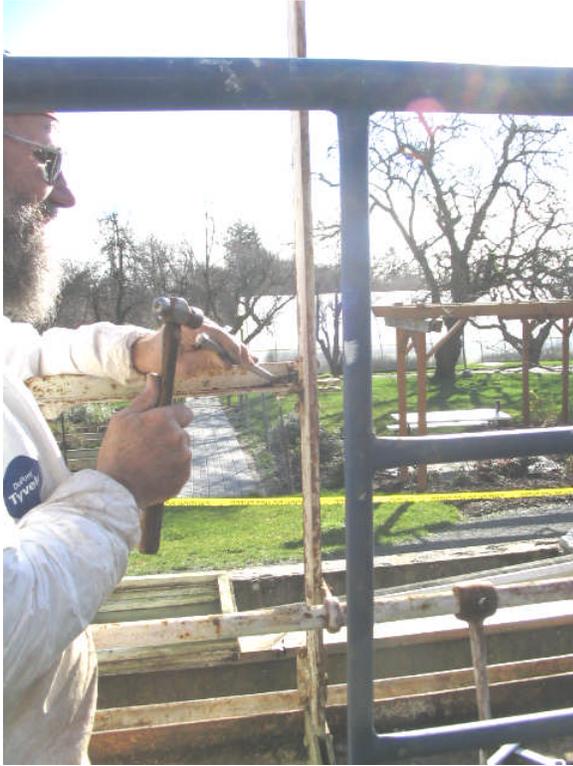
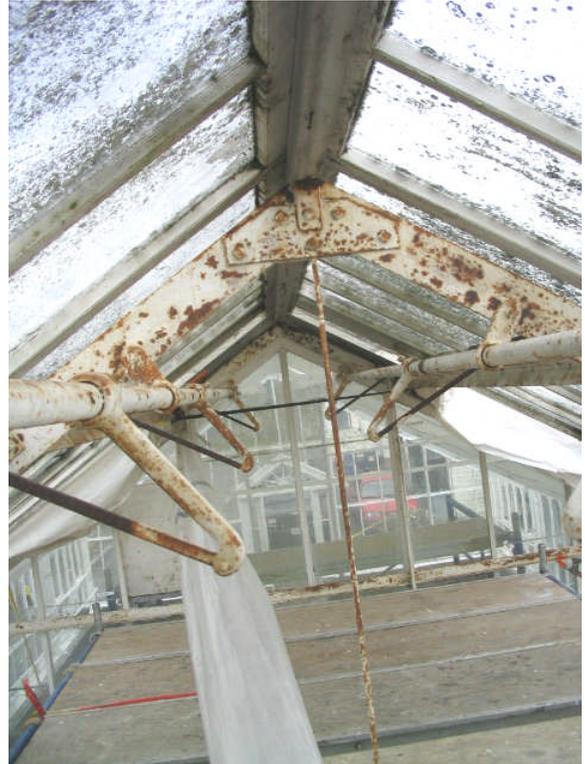
Thorough cleaning and lubrication maintain proper operation of the vent sashes.

Check for worn parts in the vent mechanism. Pivots, arm set screws and shaft couplers may require adjustment or repair. Oil level in the gear bath should just come to the bottom of the gear.
