Section 2 Sept. 19, 2005

Context

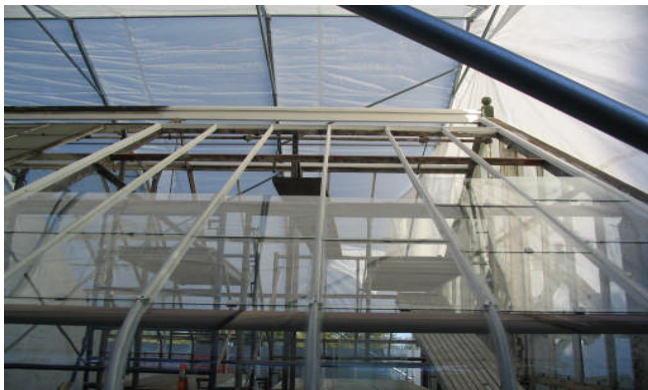
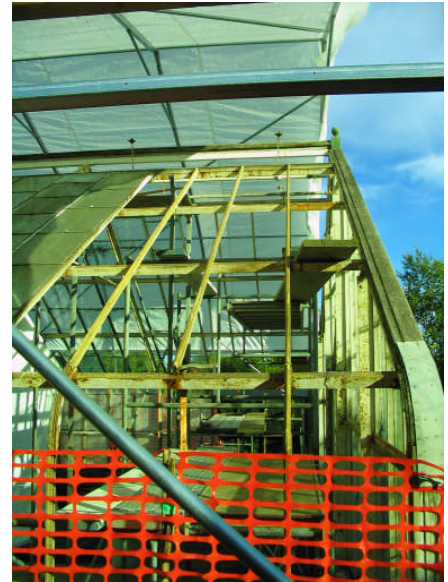
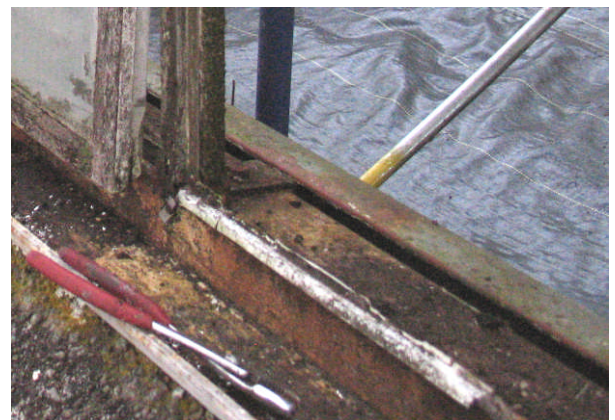
The sequence of disassembly changed to accomplish a horizontal progression from the sill upwards. All wood components are labeled based on a grid reference so replacement will match original location.

There is evidence of a flashing between the bottom of the glass and the cast sill. Most wood muntins are sound. The exposed nose is greatly reduced from the effects of weathering.

Missing and deteriorated zinc flashing will be replaced with a custom formed light gauge copper flashing. Muntins are built up with epoxy to reconstruct a profile that will support the glazing putty.

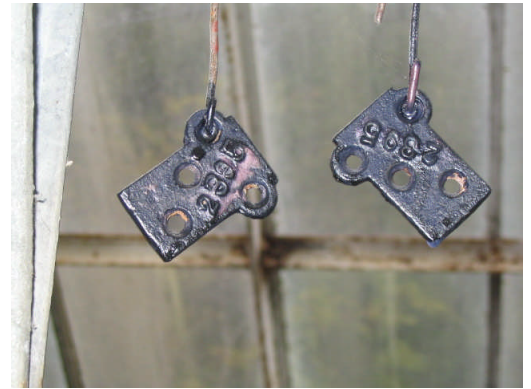
Preservation of metal is enhanced by the use of a rust conversion primer that chemically stabilizes existing rust and acts to prevent bleed through. “Conquest”, used in combination with hand metal preparation, encapsulates original steel and cast material without the extreme of power grinding and use of chemical strippers.

Encapsulation of fixed rust and paint on steel and cast components minimizes risk of damage to original hardware and reduces environmental waste: lead based paint.

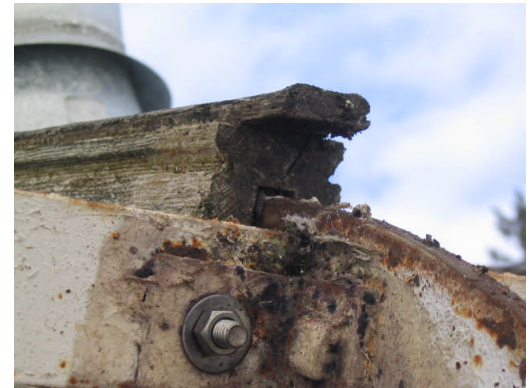
Water based rust conversion primer finished with Marine enamel creates a durable protective finish to stop deterioration of structural metal. Fill welding and cutout of corroded sections repair steel angle iron. These repairs are visible by the appearance of welding beads along the steel horizontal angles. Complete replacement will occur if 50% of the original material is lost or damaged by corrosion. Deteriorated fasteners are replaced with stainless steel to ensure extended service. Bolts and nuts are hex head in contrast to the original square shape.

Where possible, lost or broken parts are re-manufactured to maintain the original function and appearance. Contemporary fasteners are used throughout where original have deteriorated, especially any fastener in contact with wood.
