Section 4 Date: October 20,2005

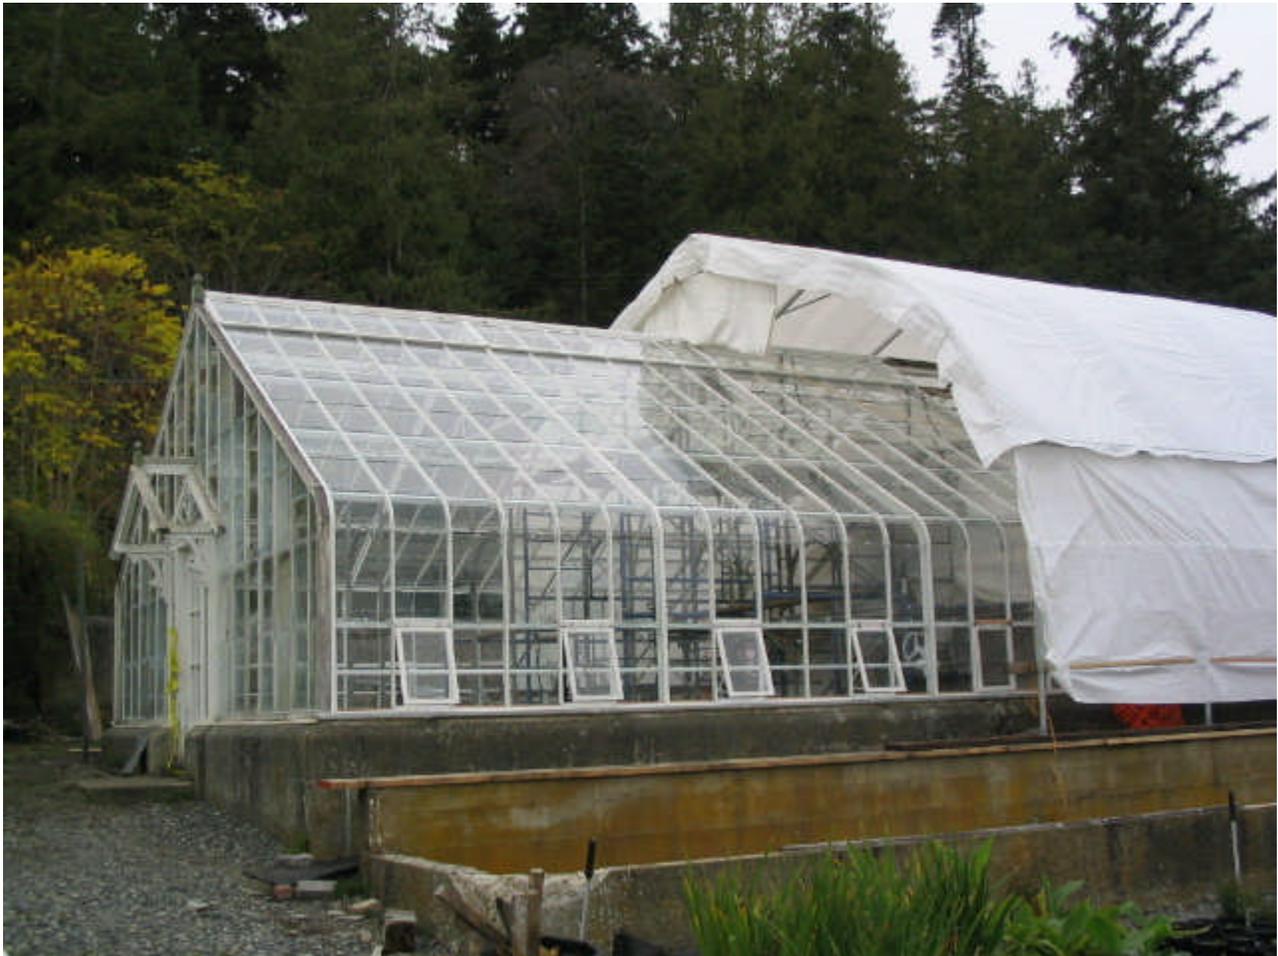
Cast fittings used to connect wood muntins and mullions to the steel structure have resisted corrosion, but the fasteners have disintegrated.

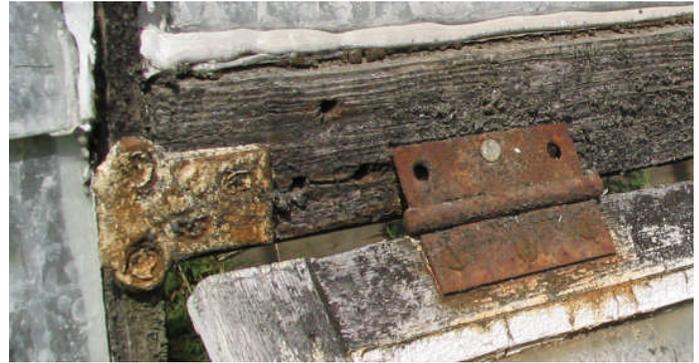
Temporary fittings required for the completion of assembly are created from original parts re-located, adapted contemporary fasteners and hand fabricated steel and aluminum pieces. These will be replaced with reproductions in cast red brass when they are available.

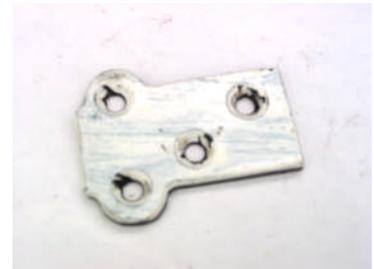
Red or Naval brass will facilitate a cost effective casting process for small quantities, as required for this project. The alloy is resistant to corrosion and has a low galvanic potential when in contact with steel and stainless steel.

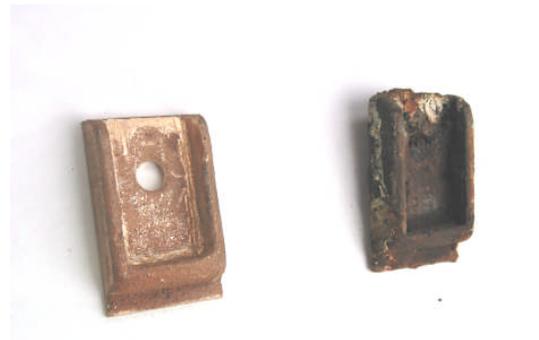
All cast iron fittings that can be salvaged are prepared with protective finishes and re-used. Broken castings are welded if all pieces can be located. Use of stainless steel bolts and wood screws will increase the strength and integrity of the structure, resisting corrosion in a marine atmosphere.

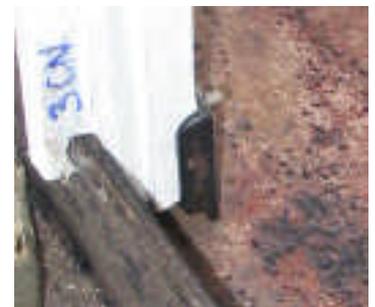
Assure that the structure of the building is sound and any change of material should contribute to extended life of service and ease of future maintenance.

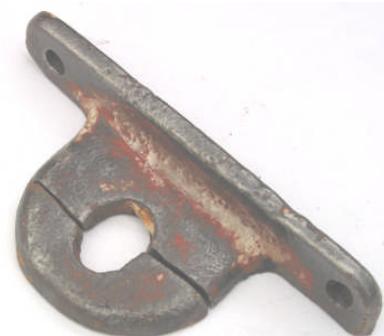
Periodic inspection will confirm fasteners are secure. If required, maintenance or replacement will be completed.
