Section 6 November 20, 2005

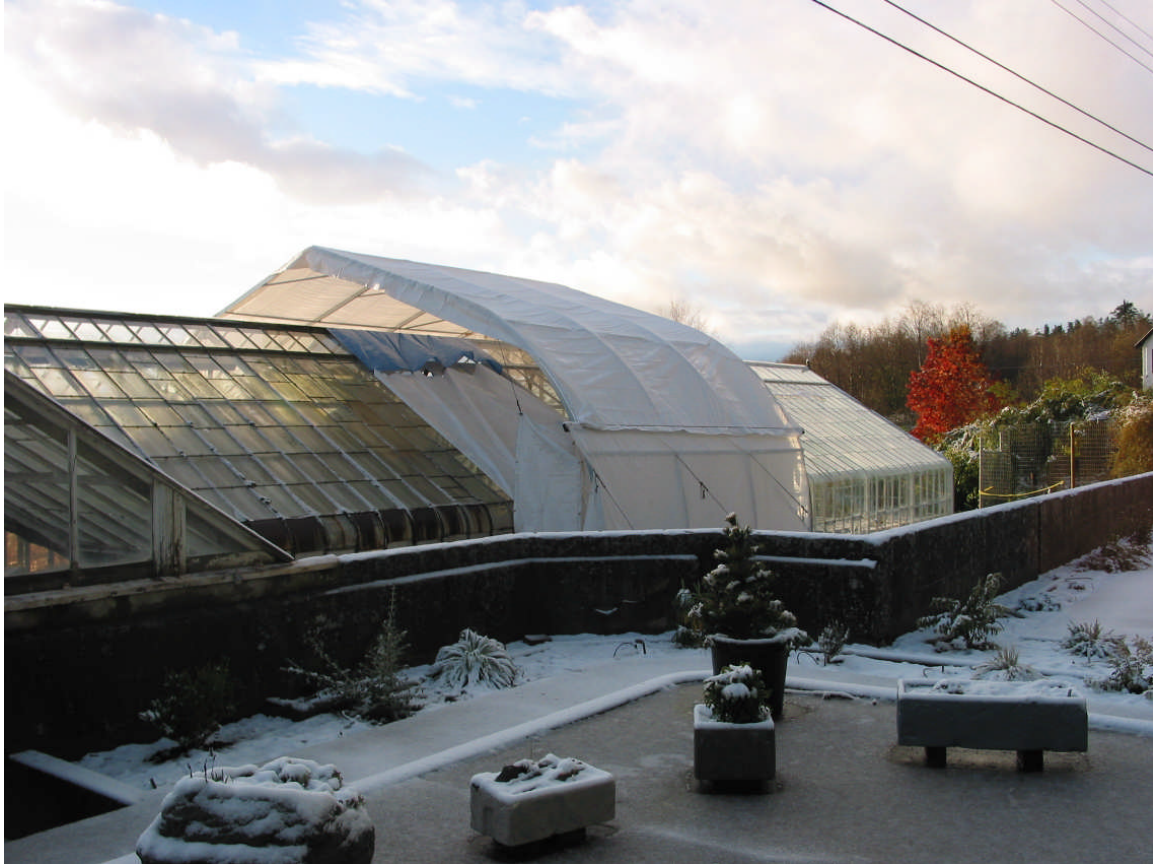
In order to add tasks to our completion cycle, efficiencies must be gained in routine tasks. Vent mechanisms require inspection and repair of broken attachment brackets, worn out pivots, bent arms, travel adjustment, frozen set screws and gear box maintenance.

In this room, we have better heat from existing forced air furnace to improve drying. As we progress through the house, we observe an increase in problems with the vent mechanism. Each assembly spans 4 of our completion sections.

Improve shelter so that painting can proceed while glass is removed. Repair vent operation by task, throughout the house.

The vent mechanism repair material will be similar to the original. Gearbox assemblies are cleaned, gear oil drained and new gear oil replenished. Shafts that suffer corrosion more than 50% of pipe wall thickness will be replaced with schedule 40 black pipe.

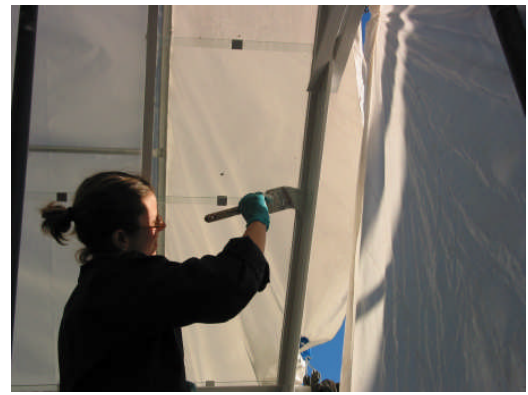
With heat, the drying time after pressure washing is reduced to overnight.

Steel and wood paint is complete prior to glass install. This saves the time of going back and working in constricted areas.

Maintain checklist of paint process to monitor sequence and completion of application. Focus on completion of paint before glass re-installation.

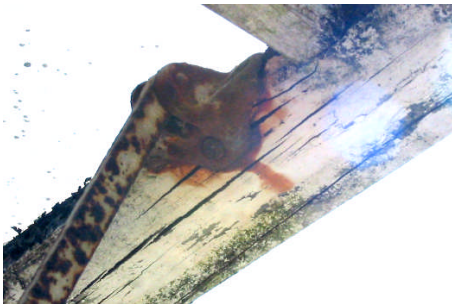
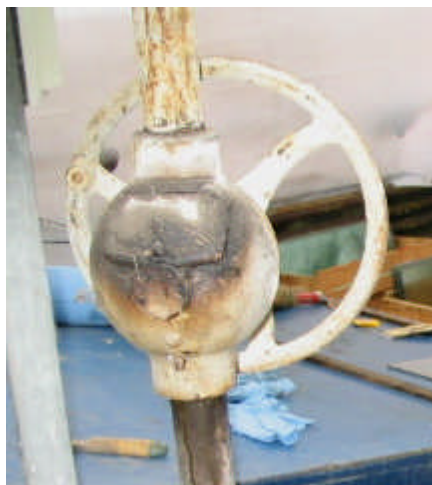
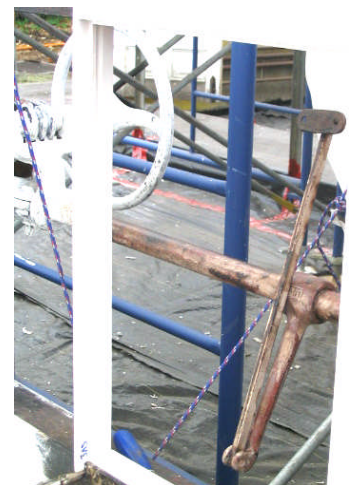
Adjust vents for proper closure and check gear oil level. Enclosures and bushings are not sealed. Gear oil leakage can be minimized by keeping the top of oil in contact of the lowest gear. Do not overfill.
