## Section 10 Jan 25, 2006

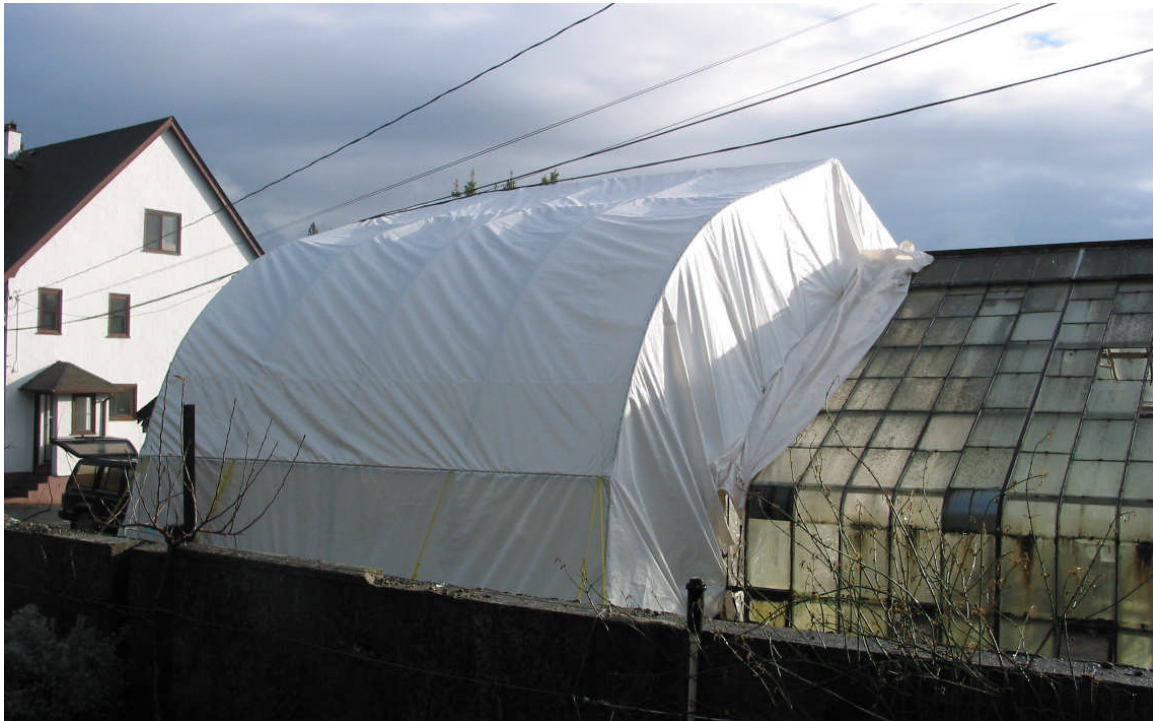
Work is proceeding without need to relocate the shelter. Time under cover has allowed the wood to dry in place and it can now be prepped once it is removed.

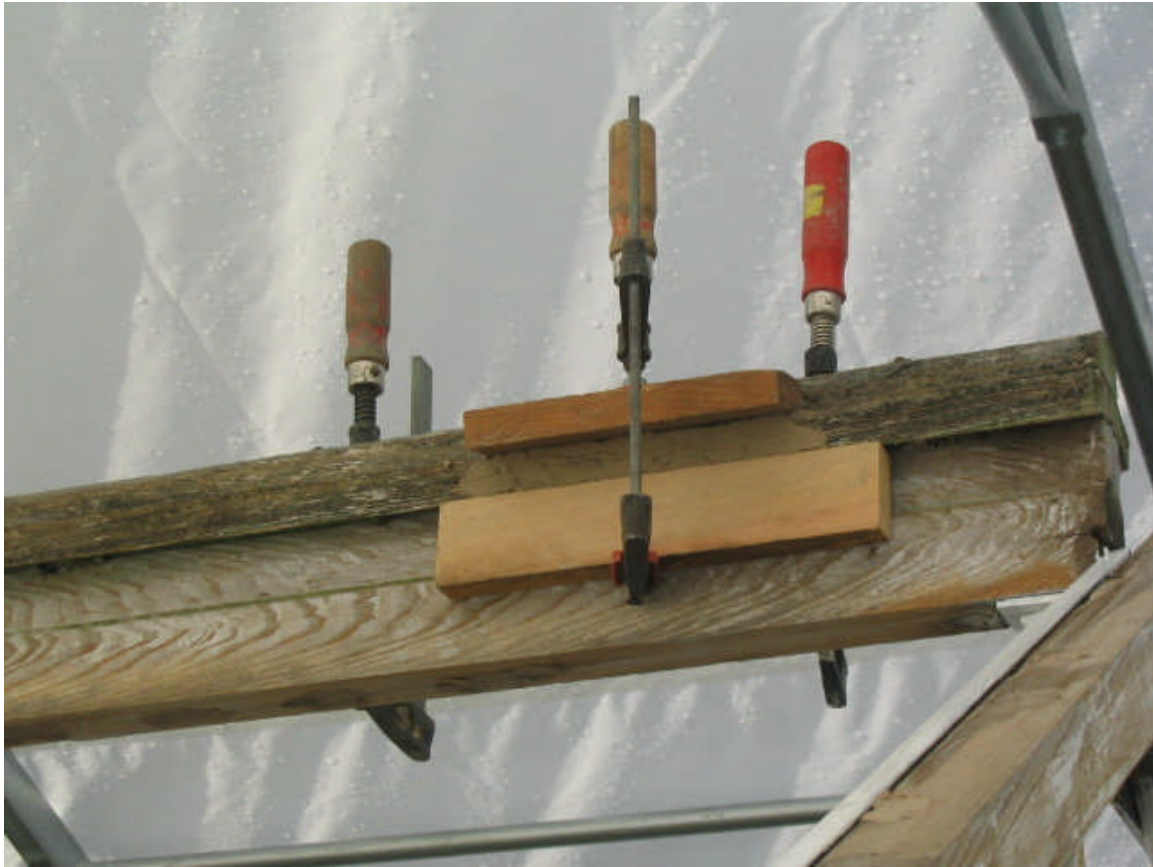
Significant corrosion of angle iron purlins requires some replacement with new material. Deterioration of wood requires extensive repair in both section 9 and 10.

Repairs to wood and steel are made in place where possible.
