Section 8 December 12, 2005

Context

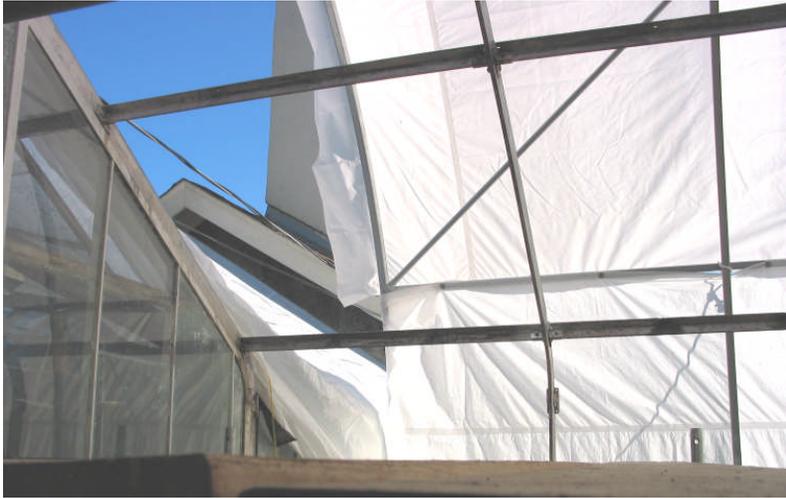
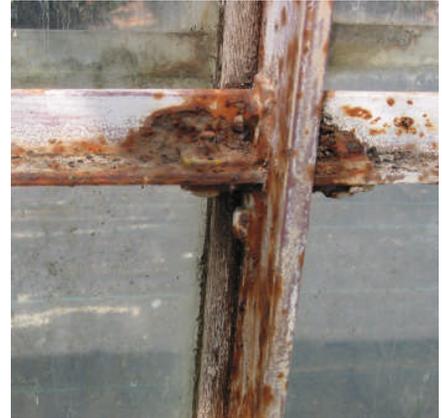
This is the last section of the south wing. We are including an additional 4 foot area that joins this building to the centre section. Some glass is removed from the centre section roof to give access to the last vertical row of glass. Access to heat from the forced air furnace will reduce the time need drying of the wood and paint finishes.

Corrosion is advanced in the angle iron purlins and the fasteners. A typical location for corrosion is above the lower vent sash. In this section, most purlins and clip angles are deteriorated. Perhaps the proximity of the chimney may have resulted in additional acidity deposited on the building from the coal and wood heating.

We have revised our flashing installation to direct run off at the lower vent sash to drain at the centre of the opening away from hinges and assembly joints.

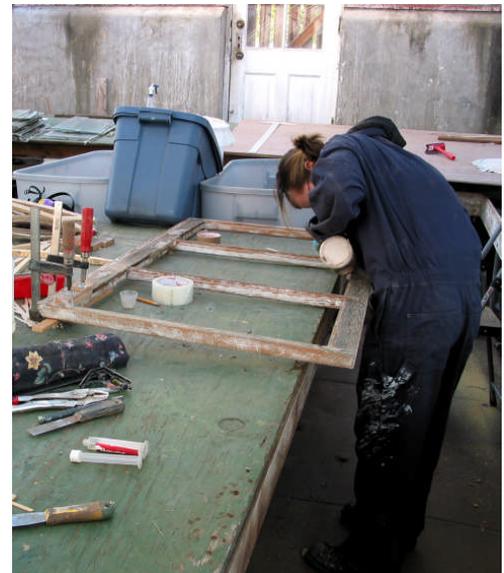
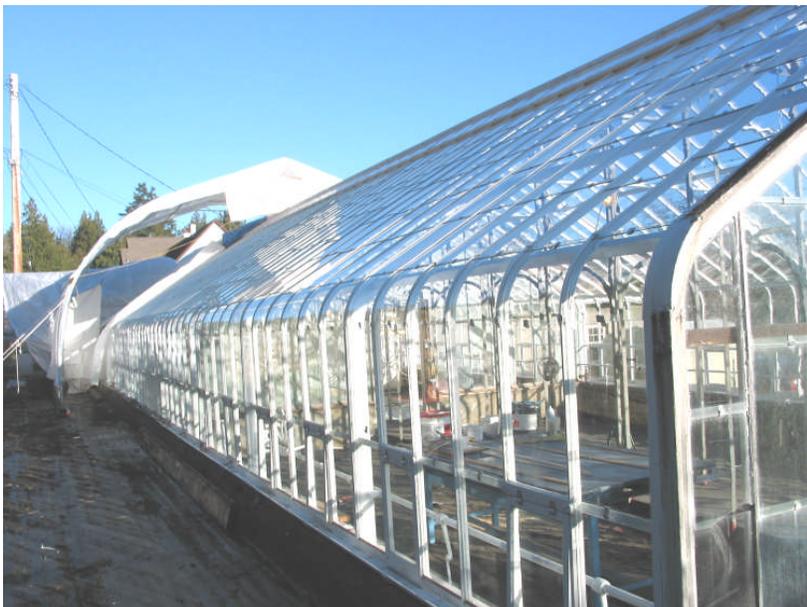
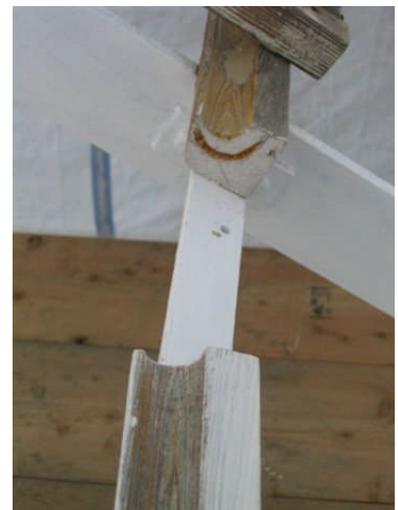
Completion of this section requires moulding to be manufactured for the frame of the lower vent sash. Maintenance of the vent mechanisms is being completed for all 8 sections.

The upper vent sash requires additional flashing at the end, to direct water away from gable intersection.

The existing half length upper vents are repaired for re-use.

Nosing for the curved eave muntins is steam bent to a mould. The result is a durable reconstruction of the original wood component.

Visual examination to assure joints are closed and tight. Gaps should be cleaned and re-caulked.
