Section 9 January 3, 2006

Context

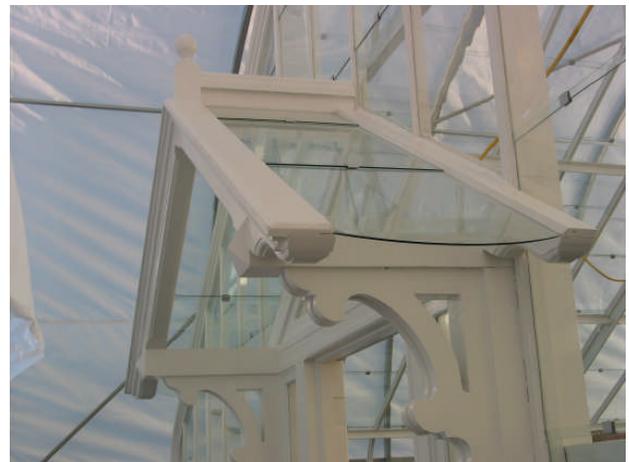
The exit door will be returned to period function with mortised hardware. Routine maintenance to lubricate lock mechanism and hinges will assure proper function.
